# PLAY AREA SAFETY INSPECTION REPORT

Aynho Parish Council

09 July 2014

Site Owner : **Aynho Parish Council**  
Site Name : Aynho Parish Council - Portway Playing Field  
Date of Inspection : 09 July 2014  
Inspected by : Rachel Adams

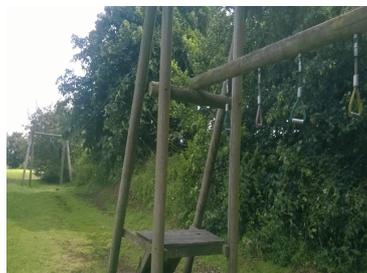
## Cableway - With Overhead Monkey Rings

Risk Level : Medium  
Risk Score : 9

The item fails to meet the requirement of the relevant standard.

The surfacing fails to meet the requirement of the relevant standard.

Comments, action or control required		Risk Level	Risk Score ‡
<b>Equipment</b>			
Finding :	Cable Loose	Medium	11
Notes :	And Traveller Knotted		
Task :	Tension Cable		
Finding :	A moving item has been attached to the structure, thereby failing the Minimum Space requirements	Medium	9
Task :	If available, fit alternative non-moving part or install barrier or appropriate safety measures		
Finding :	Item - Repair/s - Moderate	Low	7
Notes :	Tyre stops damaged and need replacing		
Task :	Replace item		
Finding :	RoSPA is concerned by accidents on some types of overhead ladders and rings. There is, however, a strong development value in these items.	Medium	8
Task :	If possible, on angled or S shaped bars, consideration should be given to level bars with firm grips and even spacings. The protective surface under all bars and rings must be kept in good condition

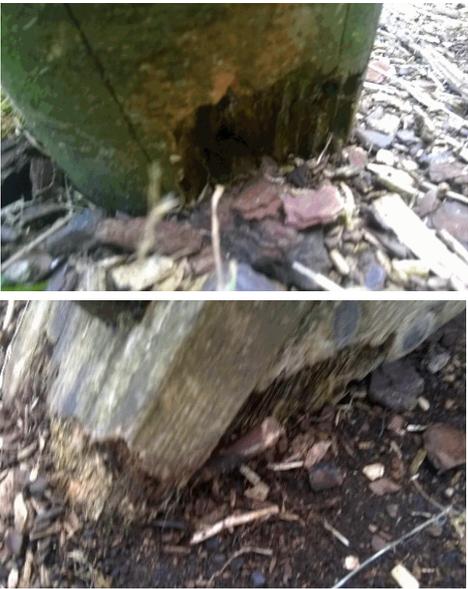
<p>Finding : There is decay to timber components which may affect structural integrity</p> <p>Finding Date : 09/07/2014</p> <p>Notes : throughout the unit</p> <div style="text-align: center;">

</div> <p>Task : Replace decayed components where possible, and plan replacement of item. Check on a routine basis, especially at ground or foundation level</p>	<p>Medium</p>	<p>8</p>
<p><b>Surfacing - Grass</b></p>		
<p>Finding : <b>Surface - Needs Repair</b></p> <p>Notes : <b>Old bark surface not fully changed to grass surface so neither one or the other.</b></p> <p>Task : <b>Repair surface</b></p>	<p>Medium</p>	<p>8</p>
<p><b>The overall risk for this item at the time of inspection:</b> ‡ For Risk Score see Report Notes</p>	<p>Medium</p>	<p>11</p>

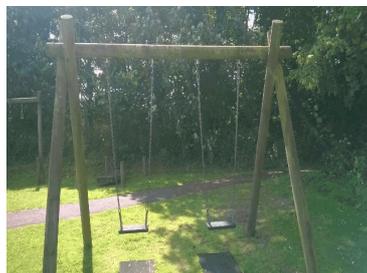
**Swings - Junior - 1 Bay 2 Seat**

Risk Level : Low  
Risk Score : 5

The item meets with the requirements of the relevant standard where this may be tested on site without dismantling or destruction.

The surfacing meets the requirements of the relevant standard.

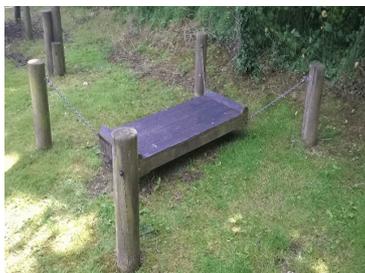
## Wobble Board

Risk Level : Very Low

Risk Score : 3

The item meets with the requirements of the relevant standard where this may be tested on site without dismantling or destruction.

The surfacing meets the requirements of the relevant standard.

Comments, action or control required	Risk Level	Risk Score ‡
<b>Equipment</b>		
Finding : Some chain wear	Low	5
Notes : D Shackles wearing		
Task : Monitor for further deterioration and replace at 40% wear		
<b>Surfacing - Grass</b> No remedial maintenance work is required at this time.		
<b>The overall risk for this item at the time of inspection:</b> ‡ For Risk Score see Report Notes	Low	5
